# Working Design of the Selected Handloom Industry for Providing a Better Quality of Life to the Workers

**Abstract:** The Handloom sector plays a very important role in the country's economy. It is one of the largest economic activities providing direct employment to over 65 lakhs persons engaged in weaving and allied activities. India has one of the richest traditions of woven textiles manufactured from wide range of different materials using variety of techniques for both functional and aesthetic purpose. Northeast refers to the easternmost region of India which is linguistically and culturally very distinct from the other states of India . Manipur enjoys a distinct place amongst the Handloom zones in India. Handloom industry is the largest cottage industry in the State. This industry has been flourishing since time immemorial. One of the special features of the industry is that there are only women weavers. In the present era of commercialization, handloom sector is also witnessing changes and large numbers of women are adopting the weaving activity as their profession. The activity they performed previously during their leisure time has now been transformed to 8hours job. But

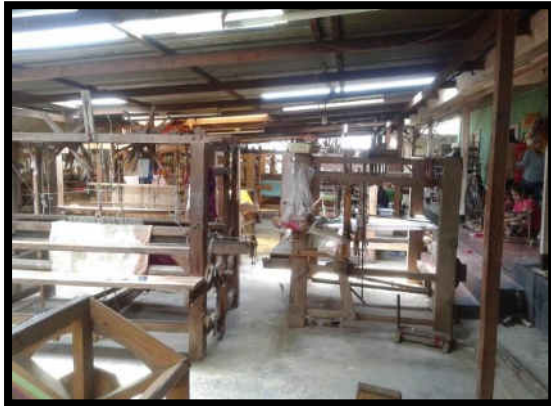
**Plate 1: Physical aspect of the unit 1**

The observation was carried out in the month of November 2015. The Handloom Unit-1 had total 21 respondents. Each respondent had one loom. The area of the Handloom Unit was 1500 square ft. According to the size of the loom and clearance space required (56 sq.ft), the area of the workplace was enough for free movement. The looms were placed in an uneven direction so the respondents were facing problem in movement from one place to another. This Handloom Unit had three walls, one wall was open. The length of the walls was 60ft, 30ft and 60ft and the height of the walls were 15ft, 8ft and 8ft.respectively. Total 2 doors and 2 windows existed in the handloom unit. There was no ventilation in the unit. The doors were located in the east direction and the windows in the west direction.

The size of the doors was 7'x3' and the windows were 4'x3'. Less light entered inside the room due to the placement of windows in the west direction. Drinking water facilities, accommodation facilities were provided but food, transportation facilities and day care centre were not provided.

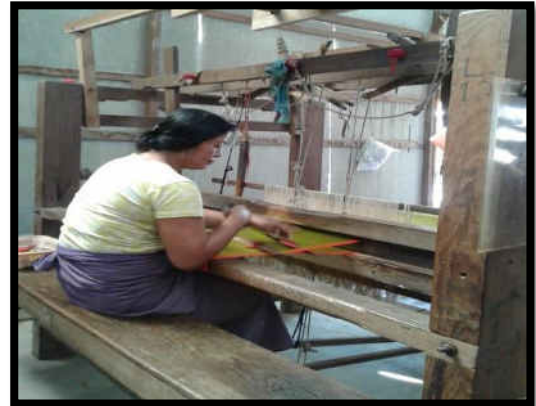
**Plate 2: Worker engaged in weaving**

There were total 14 artificial light fixtures in the handloom unit. The source of artificial light included five fluorescent lamps and nine compact fluorescent lamps (CFL). The fluorescent lamps were ceiling light with 40 watts while the compact fluorescent lamps (CFL) were pendent light with 15 to 20 watts. The wall was made up of brick having grey colour with matt finish and the flooring was of dark colour with rough finish. The ceiling was made up of tin sheet covered as a roof.

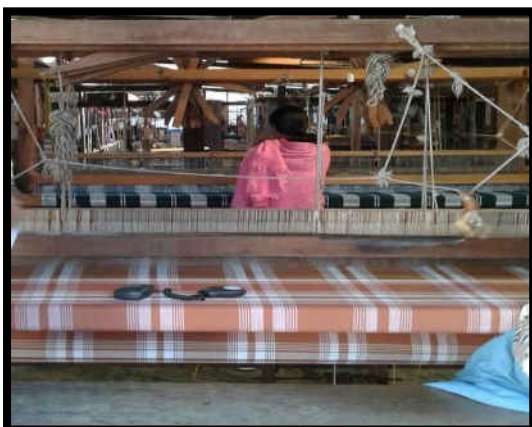
**Plate3: Reading of illumination level taken on a work Centre**

The natural illumination level was recorded three times a day i.e. in the morning 9 a.m., in the afternoon 12 p.m. and in the evening 4 p.m. respectively. At each work centre/spot natural illumination level was taken and artificial illumination level was taken only once in the evening 4 p.m. at each work centre/spot. Average noise level at each work spot was recorded. Average noise level in the units when a) all the looms are not working, b) all the looms are working and c) half of the looms are working was recorded too. Average noise level in the units when all the looms are not working was found to be 65dB, when all the looms are working it was found to be 118dB and when half of the looms are working it was found to be 89dB.

It was found out that the natural illumination level available at the sub task centre (spinning) was 209 lux though no artificial lighting was provided at the spinning centre. The daylight outside the unit (in open surrounding) was found 18900 lux at morning, 56100 lux at afternoon and 84 lux at evening. The daylight quotient resulted 1.94 in morning, 0.62 in afternoon and 49.65 in evening. The average artificial illumination level in the room was found 244.64 lux which was low according to the recommendation level of illumination and the average noise level in the room was found to be 76.19 dB which was little high according to the recommendation noise level.

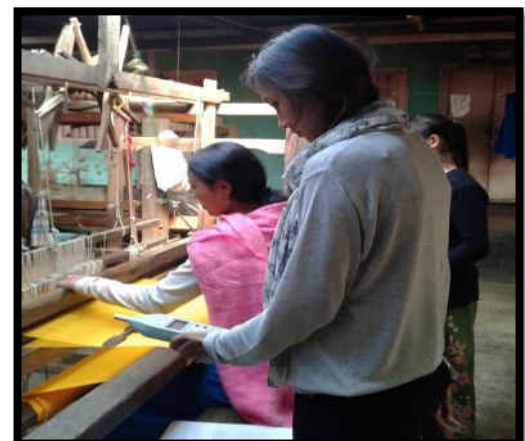
**Plate 4: Reading of noise level taken on a work Centre**

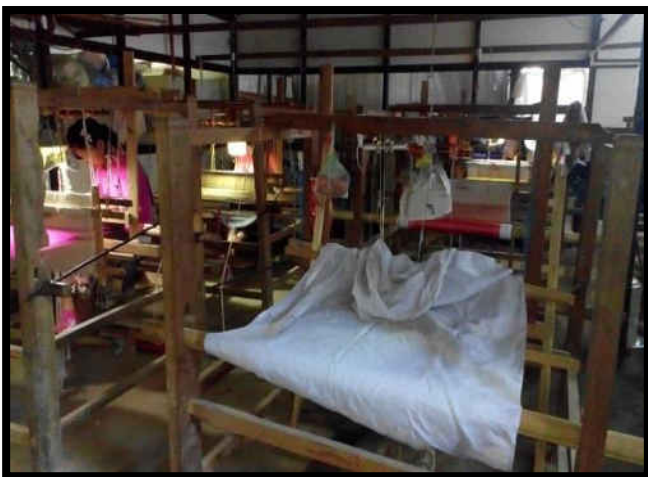
**Plate 5: Physical aspect of the unit 2**

The observation was carried out in the month of November 2015. The Handloom Unit-2 had total 16 respondents. Each respondent had one loom. The area of the Handloom Unit was 700 square ft. The size of the walls was 35ft x 20ft and the height of the walls was 15ft. ft. According to the size of the loom and clearance space required (56 sq.ft), the area of the workplace was enough for free movement. Total 1 door and 5 windows existed in the handloom unit. No ventilation was there. The doors were located in the west direction and four windows in the east direction and one window in the north direction. Sufficient light and air entered inside the room during early morning. The looms were randomly place facing in south direction. The size of the doors was 7'x3' and the windows were 4'x3'. Drinking water facilities, accommodation facilities were provided but there was no provision of food and transportation facilities and day care centre was not there.

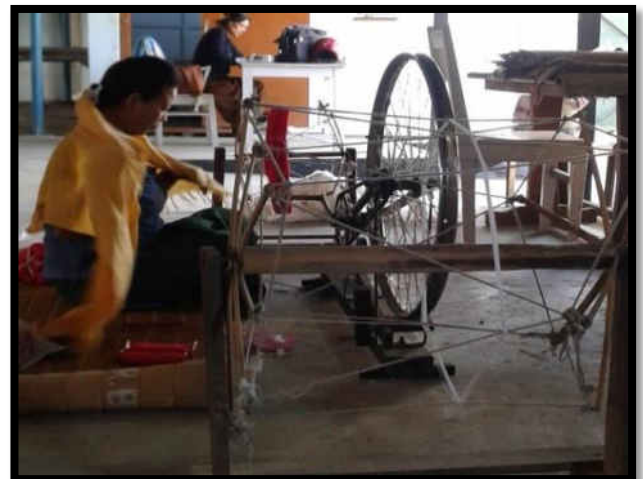
**Plate 6: Worker engaged in spinning**

There were total 16 artificial light fixtures in the Handloom Unit. The source of artificial light included only compact fluorescent lamps (CFL). The compact fluorescent lamps (CFL) were pendent light with 20 to 35 watts. The colour of the wall was white with matt finish. The flooring was concrete and the colour was grey with matt finish. The ceiling was made up of tin sheet covered as a roof.

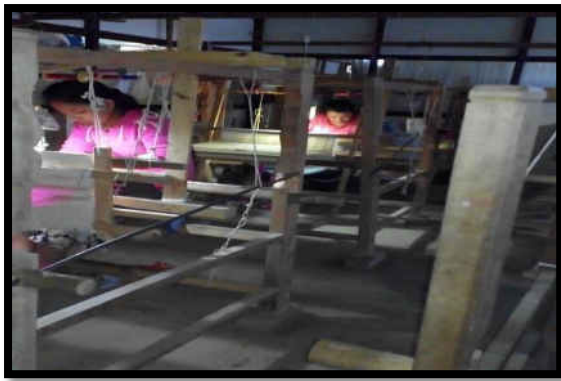
**Plate 7: Workers engaged in weaving under CFL light**

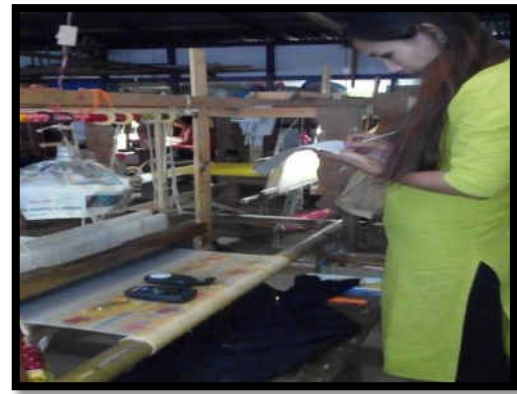
**Plate 8: Reading of artificial illumination level taken on a work centre**

The natural illumination level was recorded three times a day i.e. in the morning 9 a.m., in the afternoon 12 p.m. and in the evening 4 p.m. respectively. At each work centre/spot natural illumination level was taken and artificial illumination level was taken only once in the evening 4 p.m. at each work centre/spot. Average noise level at each work spot was recorded. Average noise level in the units when a) all the looms are not working, b) all the looms are working and c) half of the looms are working was recorded too. Average noise level in the units when all the looms were not working was found to be 60.4dB, when all the looms were working it was found to be 62.2dB and when half of the looms were working it was found to be 60.1dB.

It was found out that the natural illumination level available at the sub task centre (spinning) was 106 lux though no artificial lighting was provided at the spinning centre. The daylight outside the unit (in open surrounding) was found 17800 lux at morning, 38700 lux at afternoon and 45 lux at evening. The daylight quotient resulted 0.21 in morning, 0.09 in afternoon and 35.55 in evening. The average artificial illumination level in the room was found 445.31 lux which was low according to the recommendation level of illumination and the average noise level in the room was found to be 60.28 dB which was normal according to the recommendation noise level.

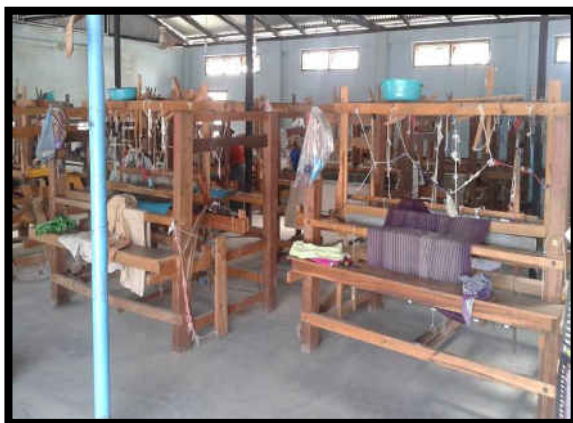
**Plate 9: Physical aspect of the unit 3**

The observation was carried out in the month of November 2015. The total numbers of respondents in this Unit were 20. Each respondent had one loom. The area of the handloom unit was 1800 square ft. According to the size of the loom and clearance space required (56 sq.ft), the area of the workplace was enough for free movement. The size of the walls was 60ft x 60ft and the height of the walls was 15ft. A door was located at the corner of the unit and it was directed towards west. 6 ventilations existed in the Handloom Unit and each of 6 ventilations were located in the west direction. Sufficient light and fresh air entered inside the workplace during daytime. The looms were placed unevenly facing each other. The size of the door was 7'x3' and the size of the ventilator was 1'x3'. Drinking water facilities, accommodation facilities were provided but there was no provision of food and transportation facilities and day care centre were not provided.

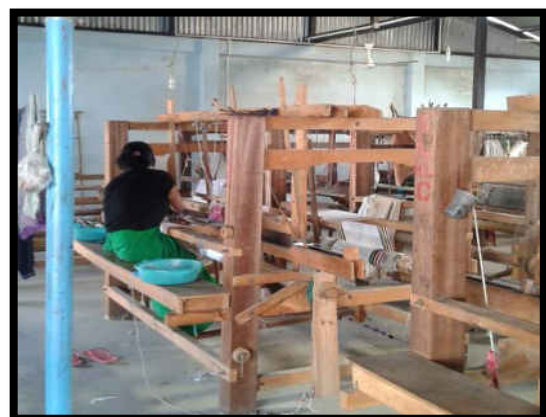
**Plate 10: Pendant light fixture above the work Centre**

The source of artificial light included 6 fluorescent lamps and 7 compact fluorescent lamps (CFL). The fluorescent lamps were ceiling light with 40 watts while the compact fluorescent lamps (CFL) were pendant light with 20 to 35 watts. The wall was made up of brick and white colour was applied with matt finish and the flooring was concrete with grey colour with smooth finish. The ceiling was made up of tin sheet covered as a roof.

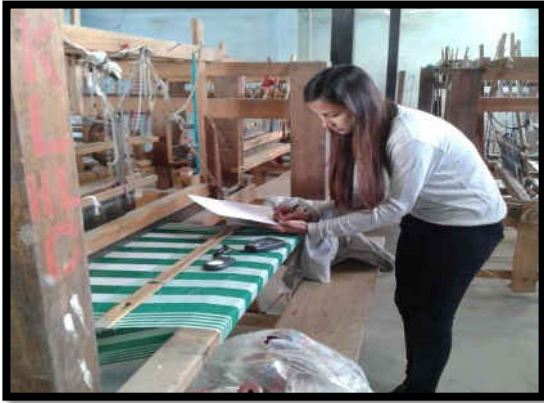
**Plate 11: Recording illumination level at a spot**

The natural illumination level was recorded three times a day i.e. in the morning 9 a.m., in the afternoon 12 p.m. and in the evening 4 p.m. respectively. At each work centre/spot natural illumination level was taken and artificial illumination level was taken only once in the evening 4 p.m. at each work centre/spot. Average noise level at each work spot was recorded. Average noise level in the units when a) all the looms are not working, b) all the looms are working and c) half of the looms are working was recorded too.

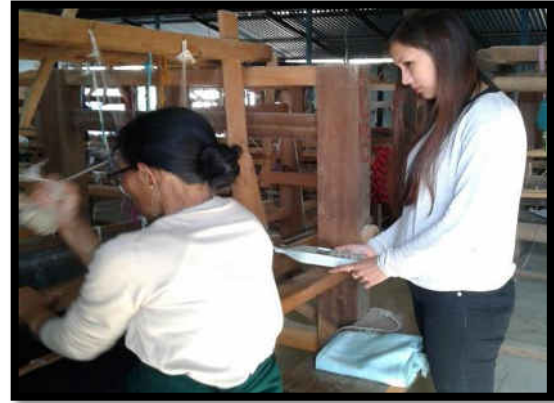
**Plate 12: Recording of sound level while performing the task**

Average noise level in the units when all the looms were not working was found to be 65.4dB, when all the looms were working it was found to be 96dB and when half of the looms were working it was found to be 80.6dB. It was found out that the natural illumination level available at the sub task centre (spinning) was 89 lux though no artificial lighting was provided at the spinning centre. The daylight outside the unit (in open surrounding) was found 18100 lux in morning, 35000 lux in afternoon and 56 lux in evening. The daylight quotient resulted 1.29 in morning, 0.66 in afternoon and 29.46 in evening. The average artificial illumination level in the room was found 117.84 lux which was low according to the recommendation level of illumination and the average noise level in the room was found to be 75.86 dB which was high according to the recommendation noise level.

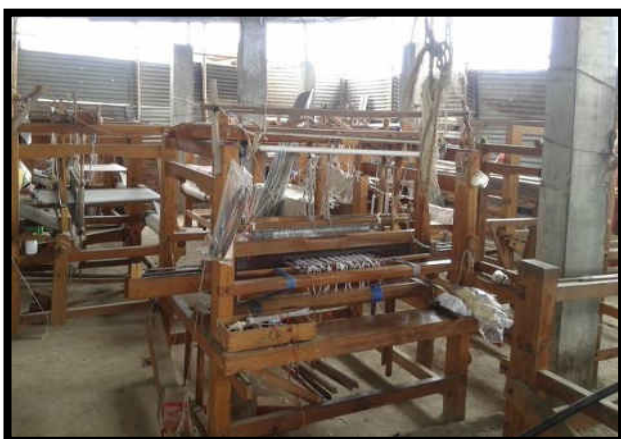
**Plate 13: Physical aspect of the unit 4**

The observation was carried out in the month of November 2015. The Handloom Unit-4 had total 25 respondents. Each respondent had one loom. The area of the Handloom Unit was 1200 square ft. The size of the walls was 40ft x 30ft and the height of the walls was 10ft. According to the size of the loom and clearance space required (56 sq.ft), the area of the workplace was found to be very small for the placement of 25 looms and for free movement of the workers. A door was located at the centre of a wall and it was directed towards west. The Unit was under construction so windows were not fixed yet. The looms were placed unevenly facing each other.

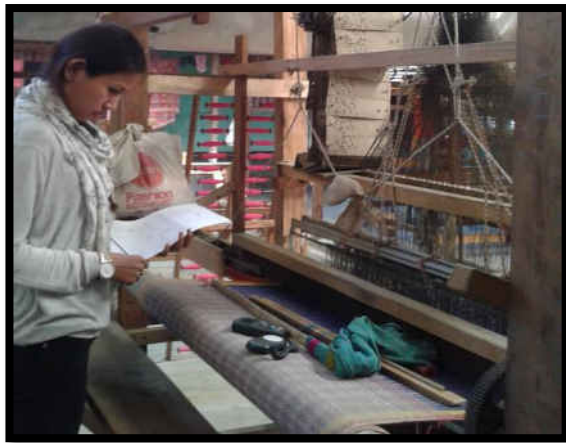
**Plate 15: Recording natural light at a spot**

The natural illumination level was recorded three times a day i.e. in the morning 9 a.m., in the afternoon 12 p.m. and in the evening 4 p.m. respectively. At each work centre/spot natural illumination level was taken .Average noise level at each work spot was recorded. Average noise level in the units when a) all the looms are not working, b) all the looms are working and c) half of the looms are working was recorded too. Average noise level in the units when all the looms are not working was found to be 70.5dB, when all the looms are working it was found to be 110dB and when half of the looms are working it was found to be 86.3dB.

It was found out that the natural illumination level available at the sub task centre (spinning) was 205 lux though no artificial lighting was provided at the spinning centre. The daylight outside the unit (in open surrounding) was found 19300 lux at morning, 38600 lux at afternoon and 71 lux at evening. The daylight quotient resulted 2.84 at morning, 2.60 at afternoon and 15.26 at evening. The average noise level in the room was found to be 75.86 dB which was little bit high according to the recommendation noise level.

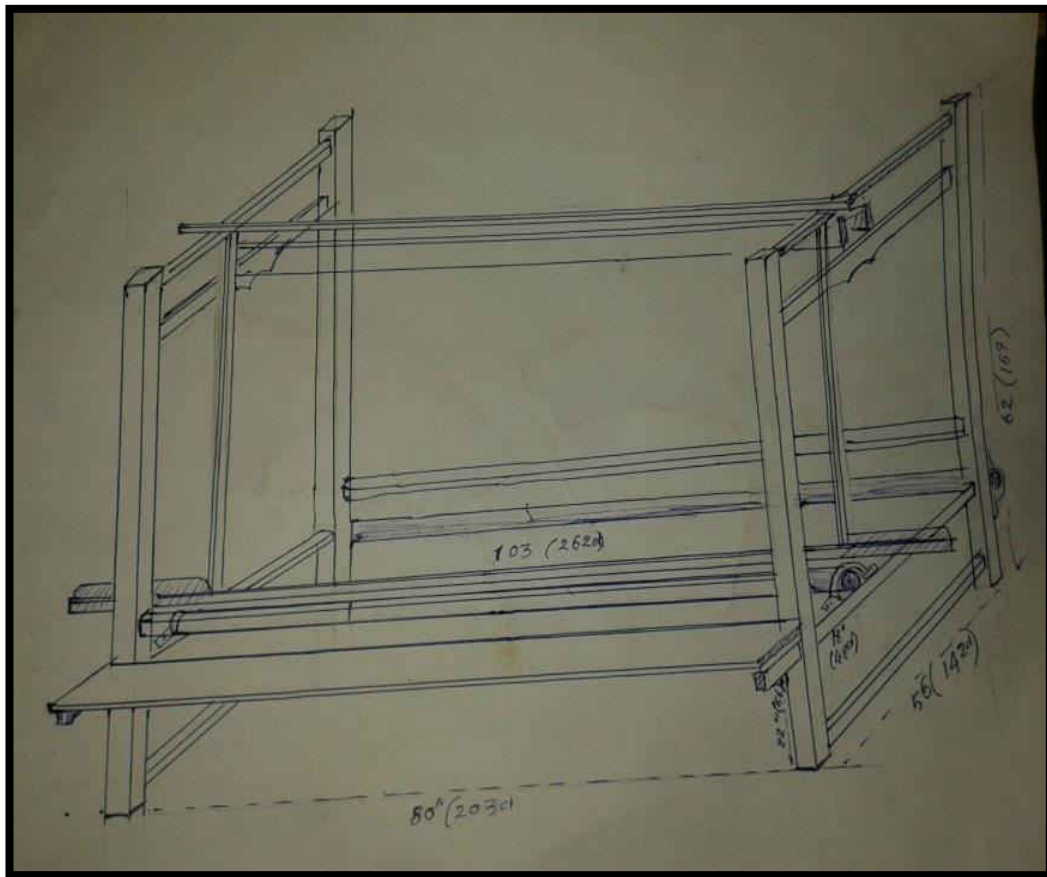
The existing floor plan of the unit was 1200sq.ft. There were 25 numbers of looms in this unit. A 7'x6' size of door was located at the centre of the unit. There were 12 windows but it was not fixed yet as the unit was under construction. Taking this advantage, a proposed working drawing was developed for the handloom unit4. The size of a weaving loom is of length 5', breath 4' and height of 5'. A minimum of 3' is required in between the looms

for clearance in movement. Including the clearance space, the size of the weaving loom was found to be 56sq.ft. The ideal space required for the placement of 25 looms is 1400sq.ft. The existing size of the floor plan was found to be small.

**Plate 17: A rough sketch of the weaving loom**

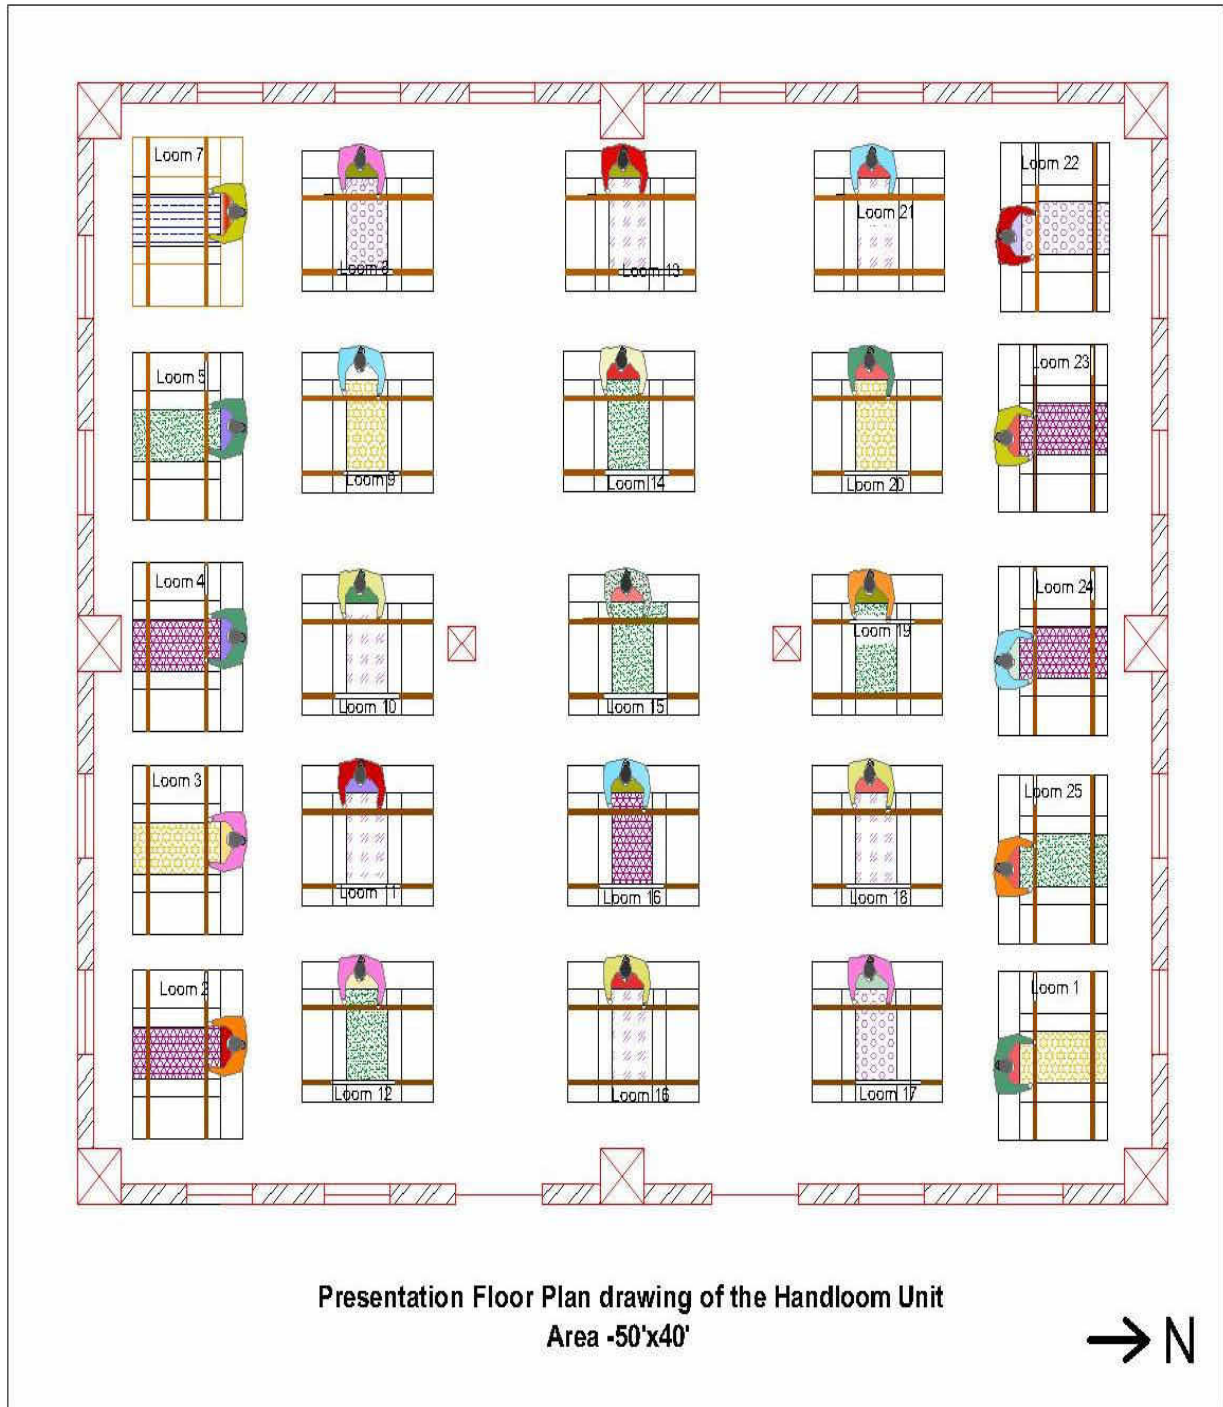
- Existing floor plan of the Handloom Unit.
- Proposed floor plan design of the Handloom Unit.
- Proposed presentation drawing of the Handloom Unit.
- Proposed four wall elevation of the Handloom Unit.
- Proposed electrical layout of the Handloom Unit.

An 800sq.ft. of space was found available just next to the Handloom Unit-4. In order to increase the size of the Handloom Unit this 800sq.ft. was merged with the 1200sq.ft. space available for the Unit. This was done in consultation with the Handloom owner in order to make the place suitable for accommodating 25 looms in it. The size of the Handloom Unit now was proposed as 50ft x 40ft and height of the wall was proposed as 15 ft.

Two doors were suggested in the proposed drawing and it was placed in the east direction and windows were provided in all the direction of the room. The height of the ventilation was suggested at 10ft from the surface. The Placement of doors and windows was done in such a way that it provided proper air circulation and entering of adequate amount of natural lighting at the workplace. It will also help in maintaining cross ventilation which will help in maintaining stable indoor temperature.

2 doors of size 8'x4', 18 windows of 4'x3' and 20 ventilations of size 1'x3' were suggested in the proposed drawing.

In the existing floor plan the loom was placed randomly in any direction. In the proposed floor plan the looms were suggested to place systematically in five rows providing enough space of movement for the workers. Five looms were installed facing in the south direction, ten looms in the east direction and five more looms in the north direction.

Various fluorescent lamps of 20 watts were suggested to be installed inside the workplace and compact fluorescent lamps (pendent light) of 25 to 30 watts were installed at above of each work centre. Sufficient drinking water facility should be provided. Provision of proper sanitation facilities near the workplace was
